ST PANCRAS CASE STUDY

Executive Summary

A new type of Side Stream Filtration and Automatic Dosing Unit (X-POT+AD) has been designed by VEXO International which incorporates dosing VEXO's X-PO10 neutral pH inhibitor to improve the efficiency of commercial heating and cooling systems.

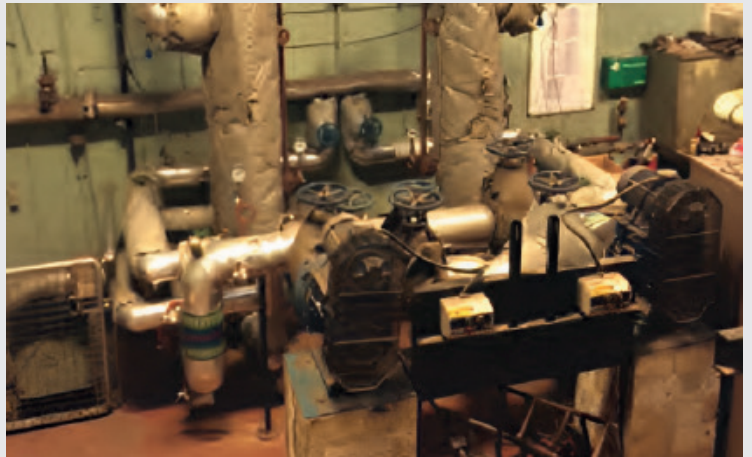
Fig 4.
Two Pullen belt driven circulating pumps with two Steam fed vertical heat exchangers.

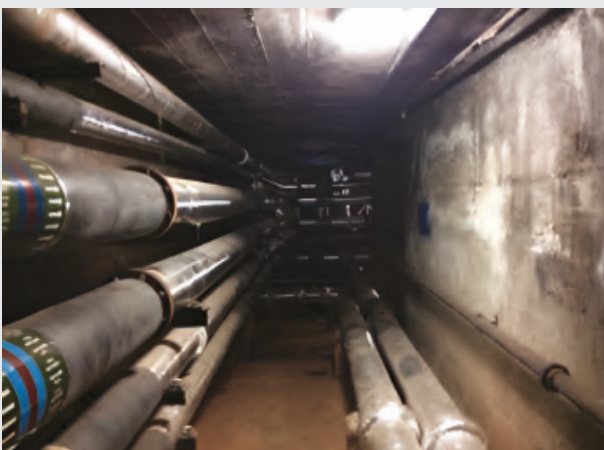
Fig 5.
LTHW pipework is routed via services tunnels to each individual building.

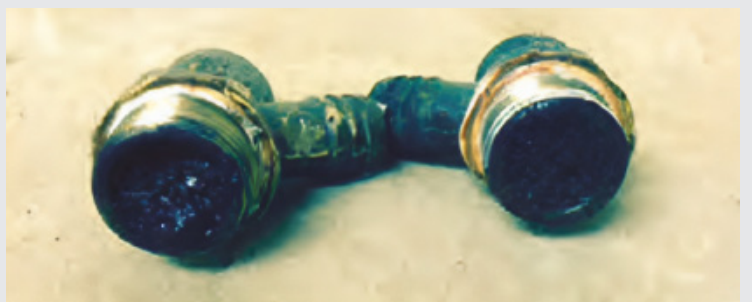
Fig 6.
Two 1/2" Brass DOCs. These were removed from a fouled pipe during a clean-up operation and show the effects of corrosion debris. Ultra fine particles that are capable of passing through system strainers will still settle out in low flow parts of a system.

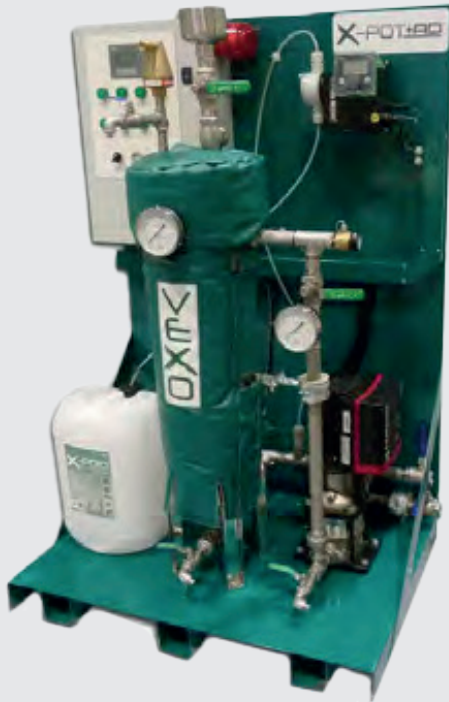
Fig 8.
Skid mounted X-POT+AD Unit.

The X-POT+AD not only ensures water quality is filtered from anywhere above 100 micron down to 0.5 micron, by using polypropylene needle felt bag filters, the unit also has 13 x 8000 Gauss Rare Earth magnets, each encased within a stainless steel coating, these magnet bars are then secured within 2No 316 Stainless Steel Magnet Grates and submerged fully within the system water.

This unique magnet grate provides a longer life cycle of the filter bags, plus it can also be used as a stand alone (without bag filter) for systems which are heavily fouled with iron oxide deposits.

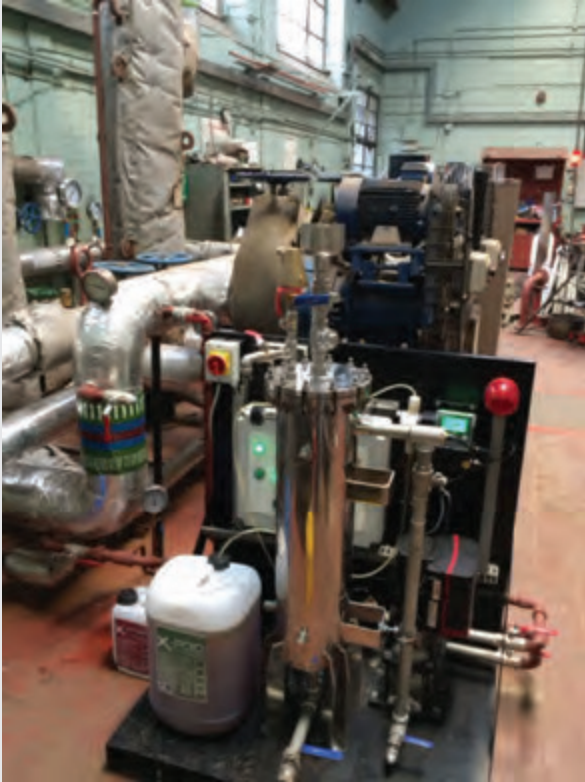
Fig 9.

The X-POT+AD Prototype was installed in the main Boiler House/Pump Room and commissioned on site on the 10th September 2014.

It was connected with 1" steel Pipework to the main system return.

As can be seen, the water treatment chemicals are visible and ready to be injected into the system via the Grundfos Auto Dosing Pump.

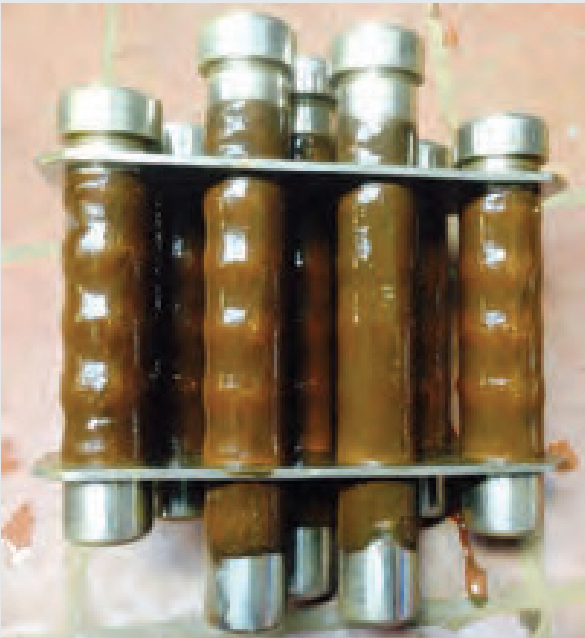
Fig 11.

Magnet Grate after 5 days (Ho Heat)

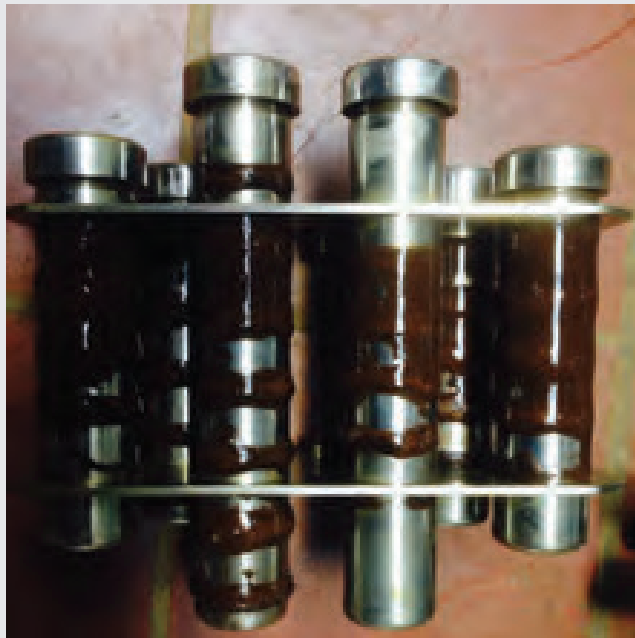
Fig 12.

Magnet Grate after 5 days (Ho Heat)

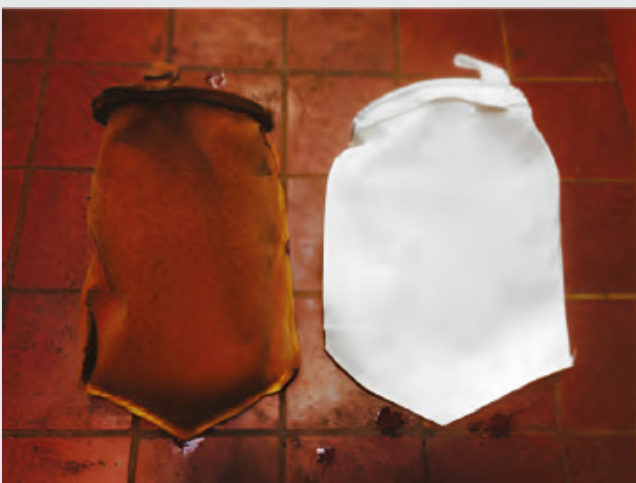
Fig 17.
First filter removed after 5 days (Day 34) with new filter ready to be added.

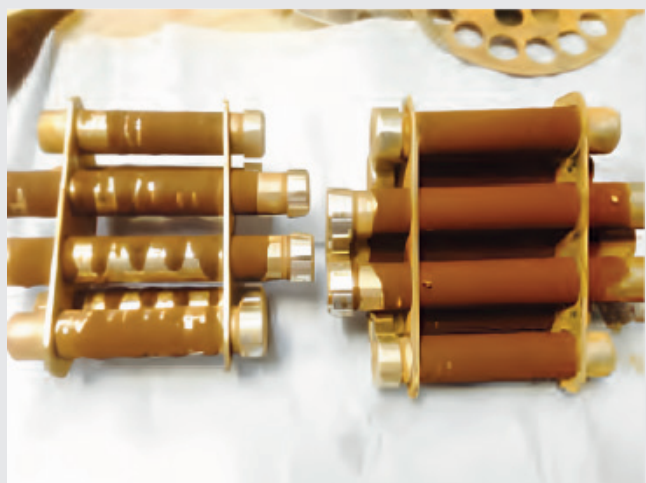
Fig 18.
Both Magnet Grates removed for cleaning (Day 34).

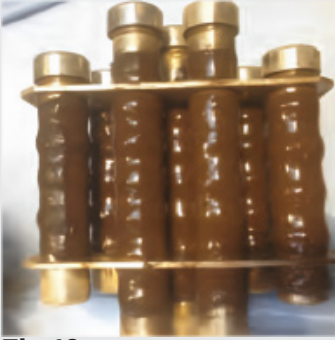
Fig 19.
Dirty Magnet Grate.

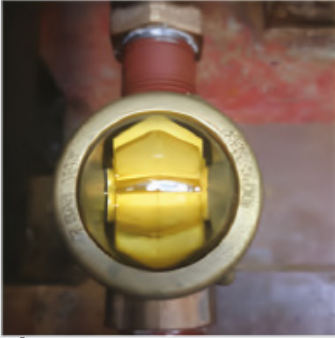
Fig 21.
The water in the Sight Flow Indicator appears clear.

The photographs of the system water above show a significant visual change to the water quality. Much of the nonsoluble Iron and Scale Deposits have now been removed.

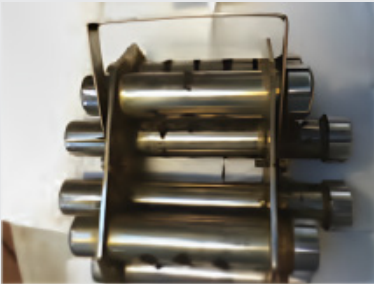
Fig 23.
6 Magnet Grate

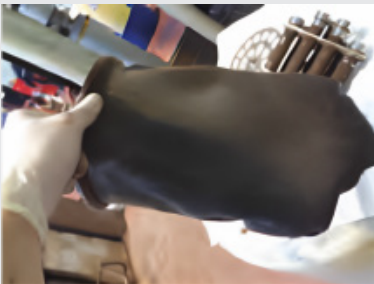
Fig 25.
Dirty 5 Micron Filter
